Manhole Inspection Summary

Manhole # S49M__021MH

Insp Date: **12/3/08 11:20 AM**

Location Address: **2500 boston st**

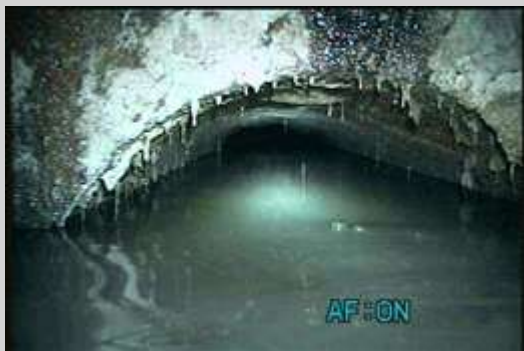
6 O'Clock Inflow

36 in. Circular Gravity Sewer
Pipe In @ 6 O'Clock

Pipe Height: 0 (in.) Direct

Infiltration: None Pipe Seal Cond: Unknown
